LIFE+ project Vopak ExperO3

Newsletter nr. 2 – May 2014

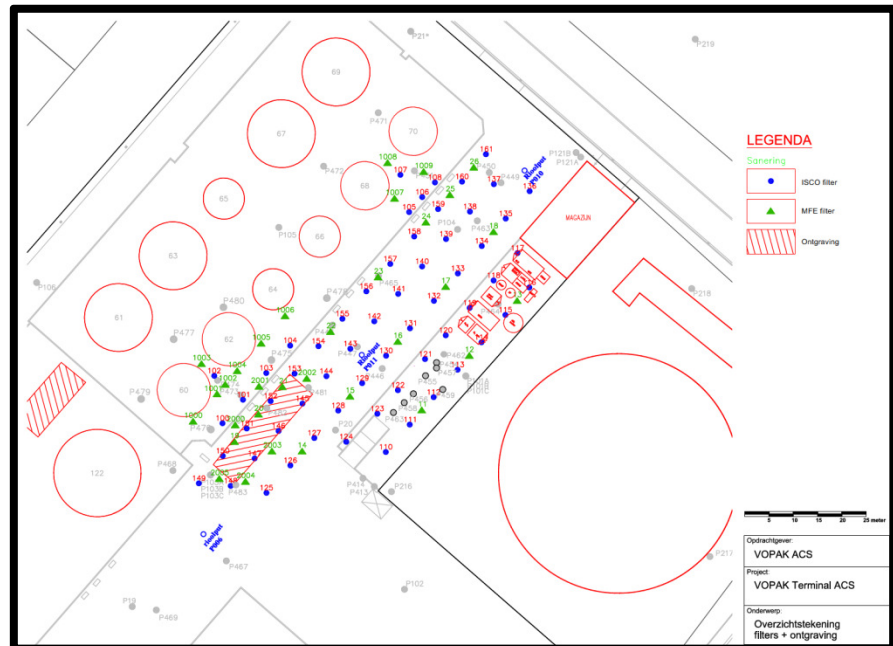
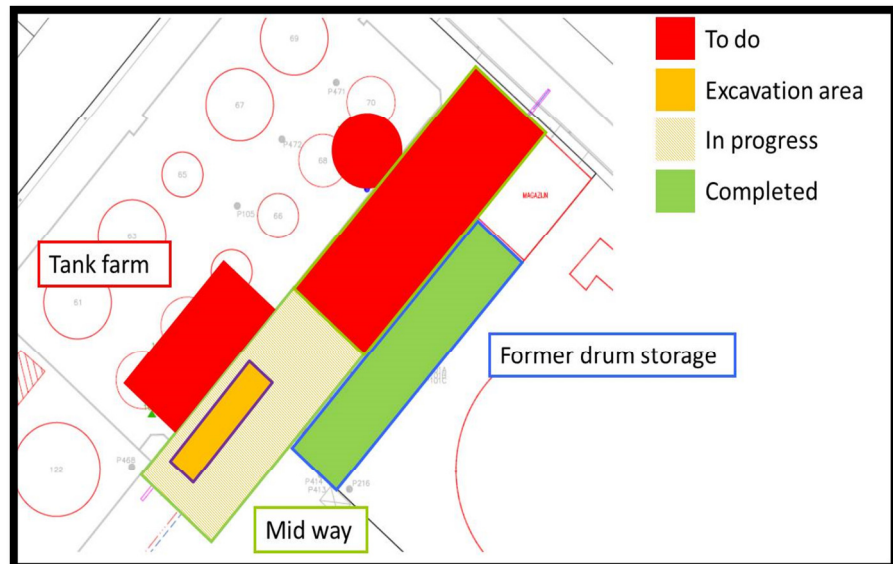
Figure 1. Remediation concept and overview of remediation progress

The general progress of the remediation works is visualized in the figure. Areas in which the remediation works have been completed, are indicated in green; those where remediation is still in progress are shown in orange and the areas where the treatment still needs to be started are in red.

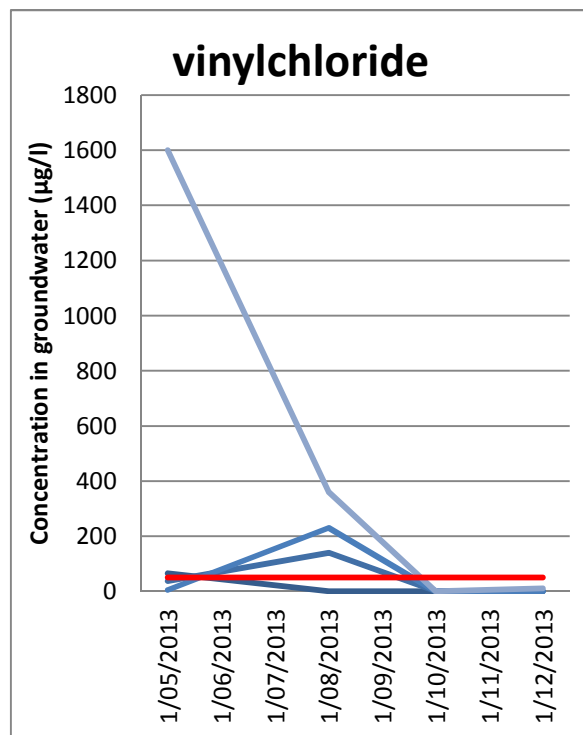
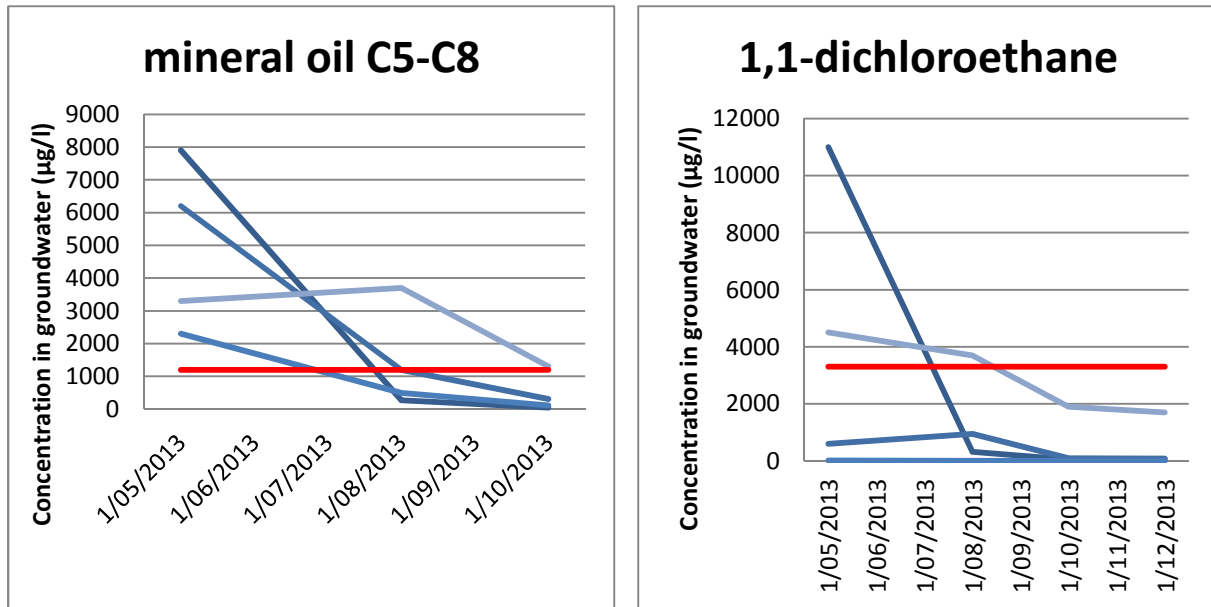
Figure 2. Charts showing the evolution of groundwater concentrations in the monitoring wells during the in-situ remediation in the former drum storage area. The blue lines indicate the concentrations in the 4 monitoring wells. The red lines show the remediation goals.

Since the start of the ISCO, a significant decrease of the contamination level was observed in the monitoring wells. The evolution of groundwater concentrations of the most important constituents in time is illustrated in the charts below.

The red lines indicate the remediation goals as defined in the remedial action plan. The blue lines are the groundwater concentrations in the different monitoring wells. The monitoring results show that for several parameters the remediation goals were already reached after 4 months. The final goals were reached in October 2013, about half a year after the start of the in-situ remediation. No emissions of ozone and/or VOC's and no subsidences have been detected during the perozone injections. There were no H&S-issues during the remediation of the drum area.
