Site visit of the Life project Vopak-EXPERO3 (LIFE09 ENV/BE/000407)
20 June 2014

Demonstration project Vopak-ExperO3

LIFE09 ENV/BE/000407

Using ISCO with perozone for the remediation of a cocktail of organic contaminants at an EX-rated industrial site in operation

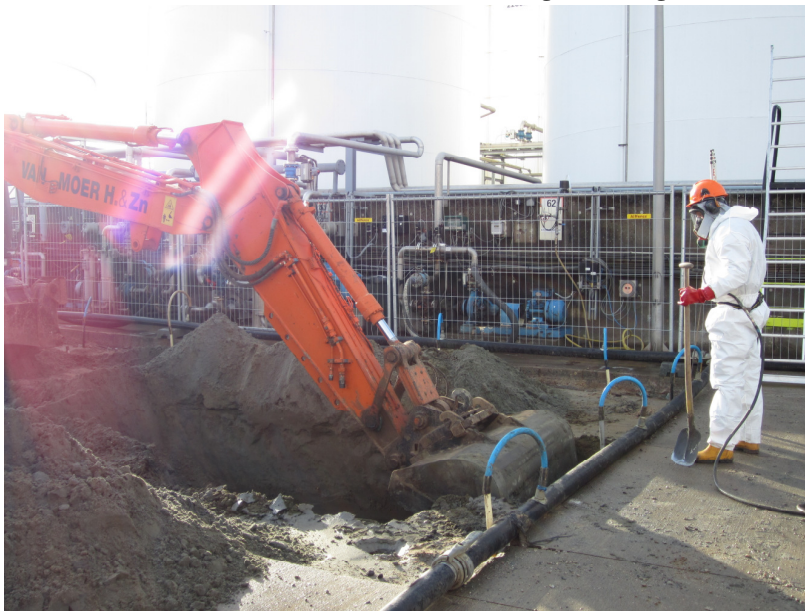
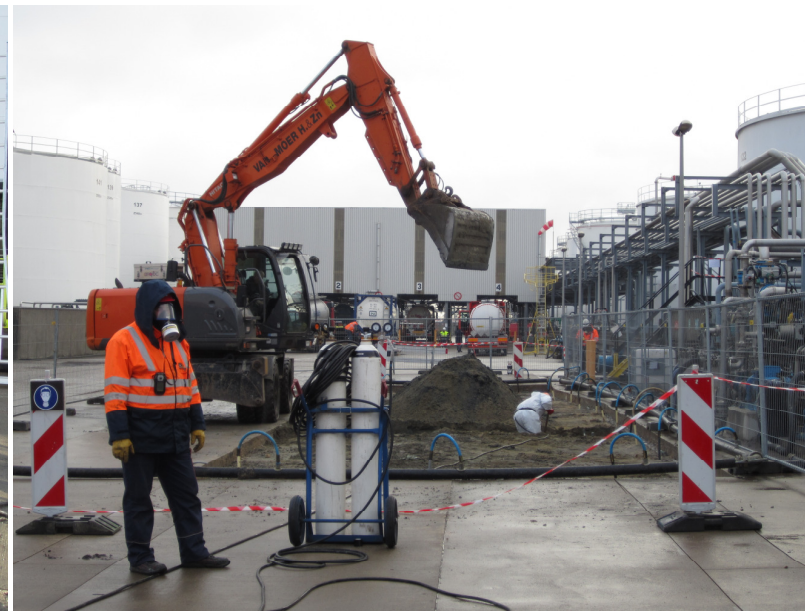
Excavation source area outside the tank farm

- Underground utility detection – trial pits
 - Manually with assistance of crane
 - Emission of contamination
 - Independent respiratory protection and gas tight and flame retardant clothes

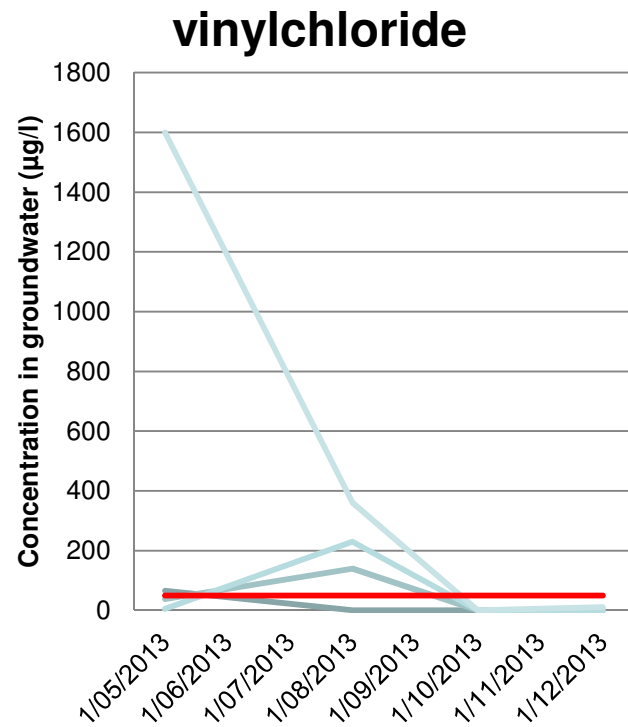
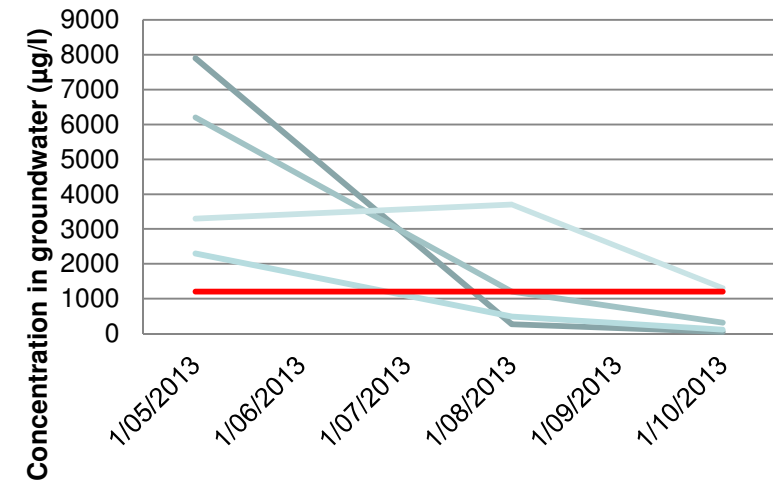
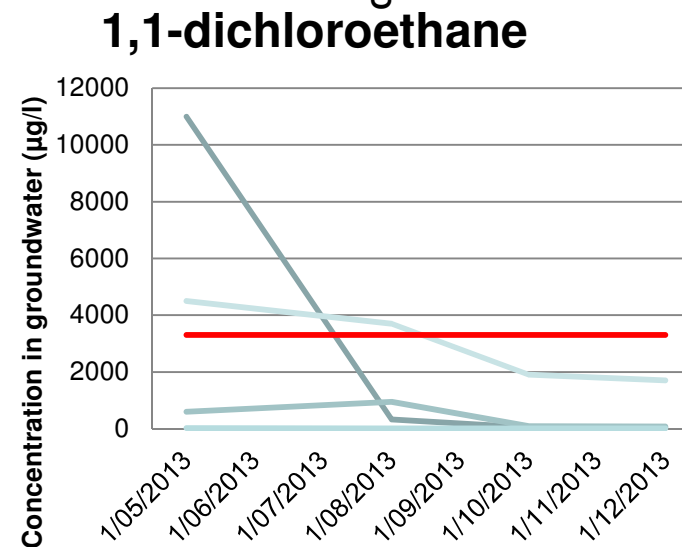
mineral oil C5-C8

- Evaluation of remediation conditions:
 - Conditions OK, however lower oxygen and ozone levels in the groundwater than expected => test with only ozone in source area
- Evaluation of trends of contaminant levels in groundwater:

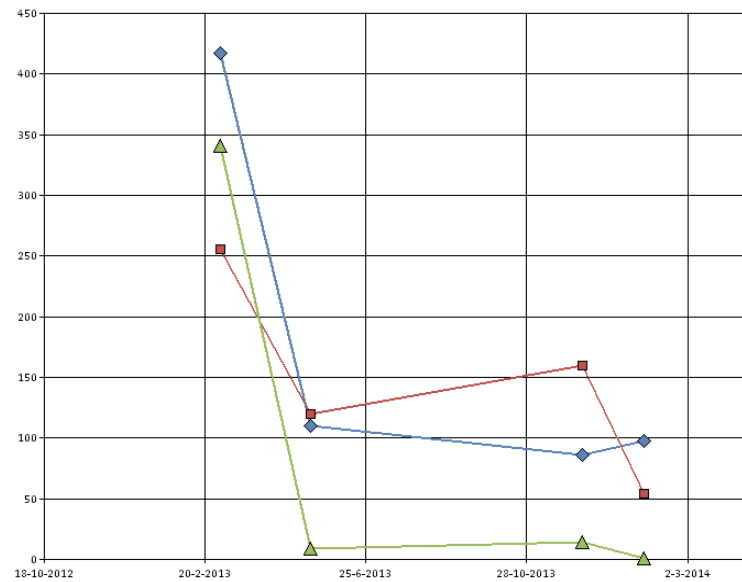
mineral oil C5-C8

- Evaluation of remediation conditions:
 - Period (November 2013 – January 2014) too short to evaluate the (positive) change in remediation conditions (oxygen level in groundwater and redox potential).
- Evaluation of trends of contaminant levels in groundwater:
