LIFE+ project Vopak ExperO3

Newsletter nr. 3 – July 2014

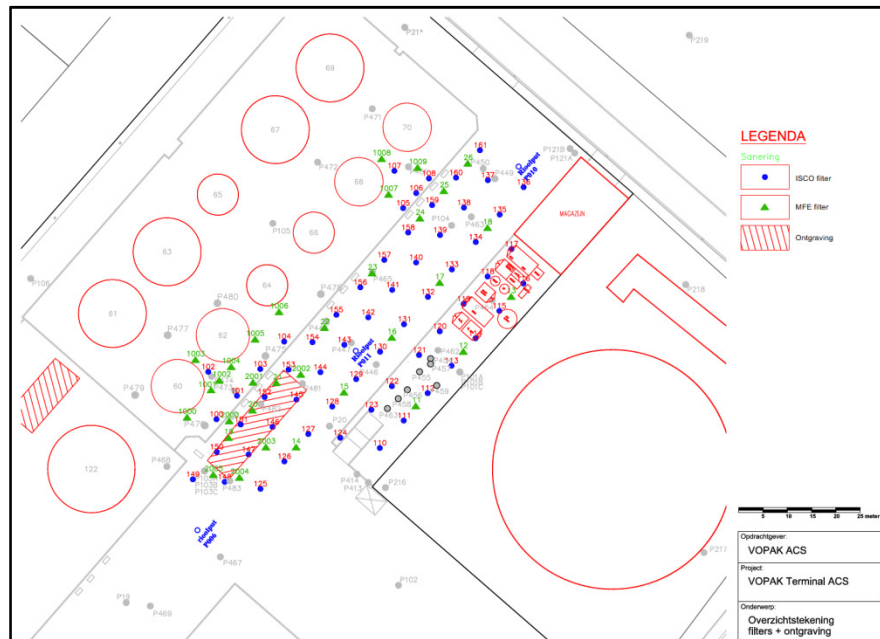
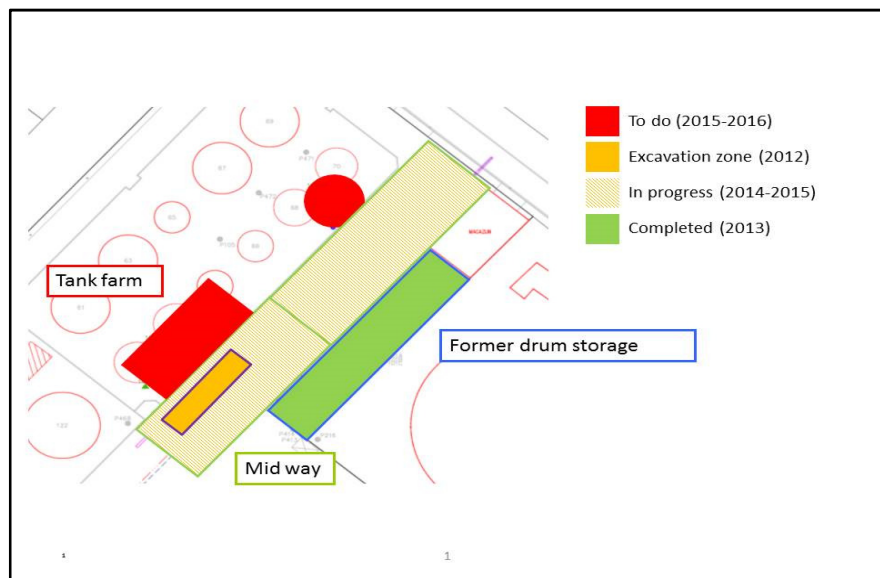
Figure 1. Remediation concept and overview of the remediation progress

The general progress of the remediation works is visualized in figure 1. Areas in which the remediation works have been completed, are indicated in green; those where remediation is in progress are shown in yellow stripes and the areas where the treatment still needs to be started are in red.

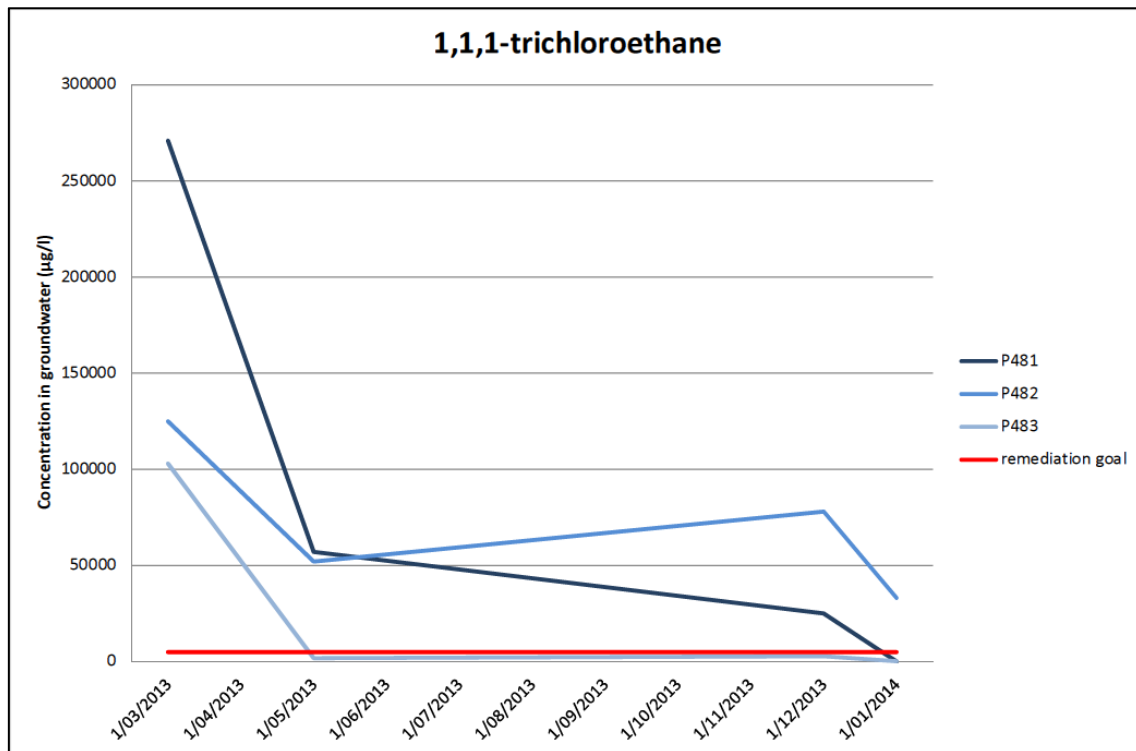
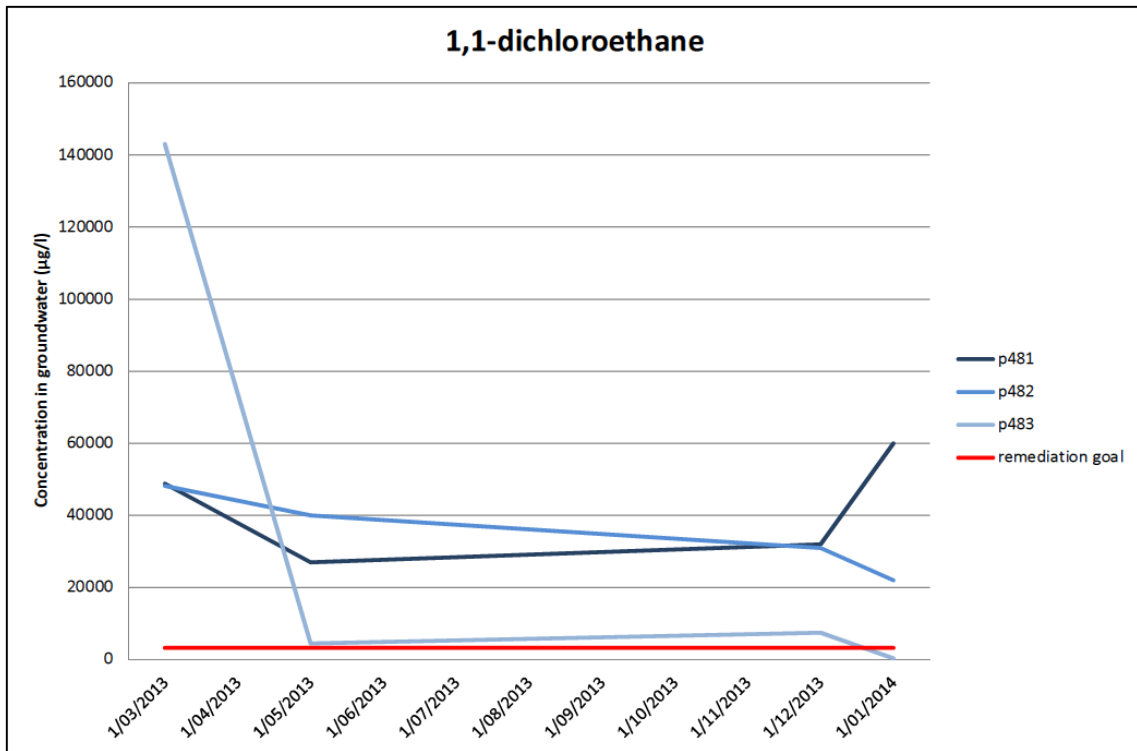
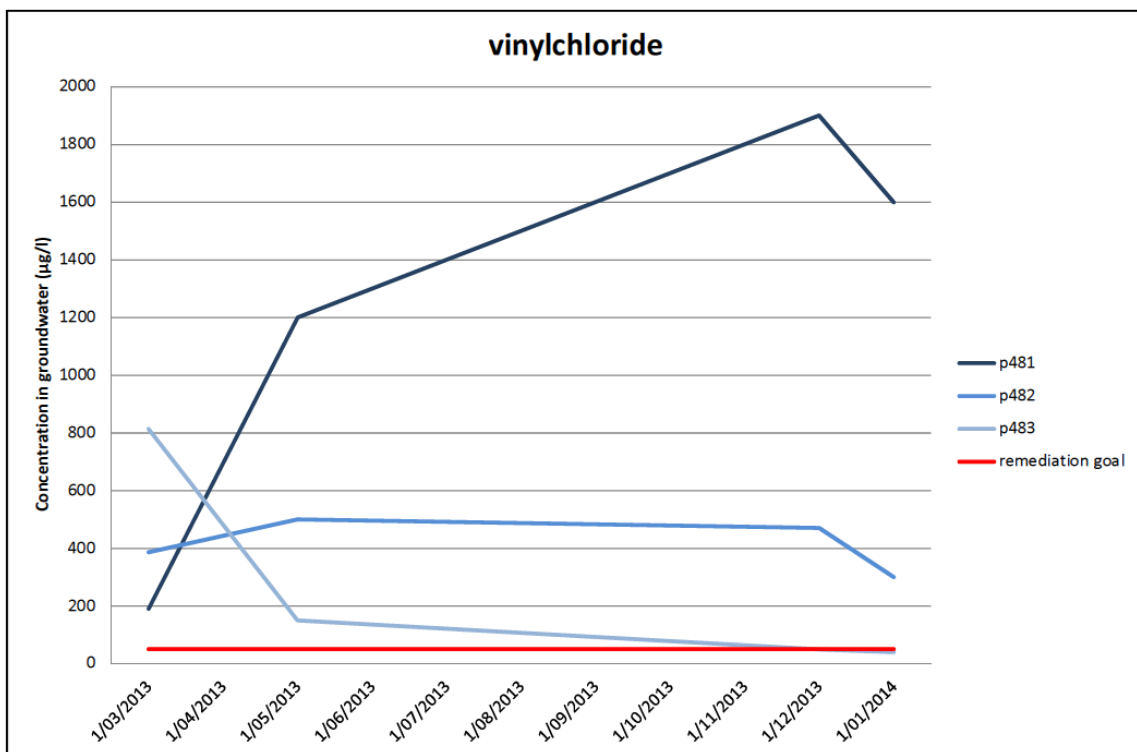
Figure 2. Charts showing the evolution of groundwater concentrations in the monitoring wells during the in situ remediation in the source area around the excavation zone. The blue lines indicate the concentrations in the 3 monitoring wells. The red lines show the remediation goals.

The graphs show a distinct decrease of most of the contaminants. In all 3 monitoring wells a decrease for 111-TCA is observed and in 2 monitoring wells the concentration of 11-DCA also decreases. In P481 the concentration of vinylchloride increased significantly until December 2013, but a decrease was measured in January 2014. In P483 the remediation goals are already reached.

Despite the encouraging monitoring results, a long-term remediation can still be expected before reaching the remediation goals, given the high contaminant mass in this area.

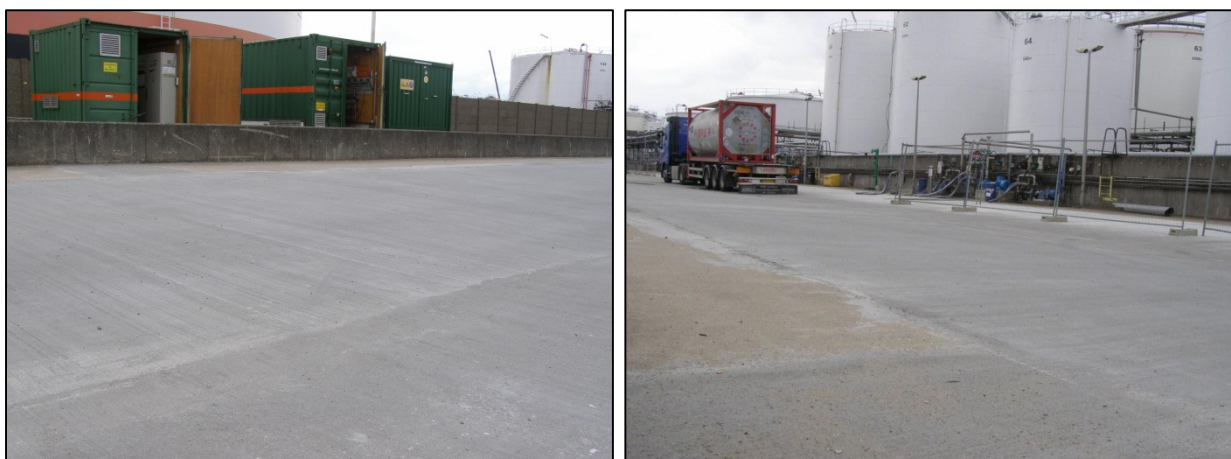
In January 2014, emissions of ozone and VOC have been observed during periods of heavy and continuous rainfall. Measurements showed ozone and VOC-concentrations of more than respectively 0,1 ppm (the odour threshold for ozone is about 0,02 ppm) and 300 ppm near fissures in the concrete floor. At breathing height, elevated ozone concentrations were only measured during intermittent and short periods. No VOC's were detected at breathing height.

The occurrence of emissions can be explained by 2 reasons. Since the concrete floor was not completely liquid tight, rainwater infiltrated in the soil and caused a local raise of the groundwater table to about 0,5 m-bgl (which in winter times normally is around 0,8 m-bgl). Due to the high groundwater table the SVE-drains were (partially) flooded and the SVE didn't work properly. The second reason is the disturbed character of the soil at the excavation area. The injected air, enriched with ozone and VOC (due to stripping) rises much faster than in undisturbed soils. Due to the shorter contact time between ozone and VOC's, not all ozone will react and both ozone and VOC's will be emitted.

Figure 3. Photos of renewed concrete cover in the midway area.

The solution should tackle both causes: the concrete floor should be completely restored and injection regimes should be adapted to the different areas.

The concrete floor was restored between February and May 2014, as illustrated in the photos. During the renewal works, the injection wells and underground piping of the ISCO were thoroughly inspected. In total 7 injection wells were clogged by sand. These wells have been cleaned and tested again. The connection of one injection point with the ozone piping has been repaired.

Moreover, 3 additional SVE drains were installed in order to guarantee better functioning of the SVE in the future and enable more accurate regulation of the SVE at the "hot spots". It is expected that no more emissions towards the atmosphere will occur. However this will be closely followed-up.
