LIFE+ project Vopak ExperO3

Newsletter nr. 4 – August 2015

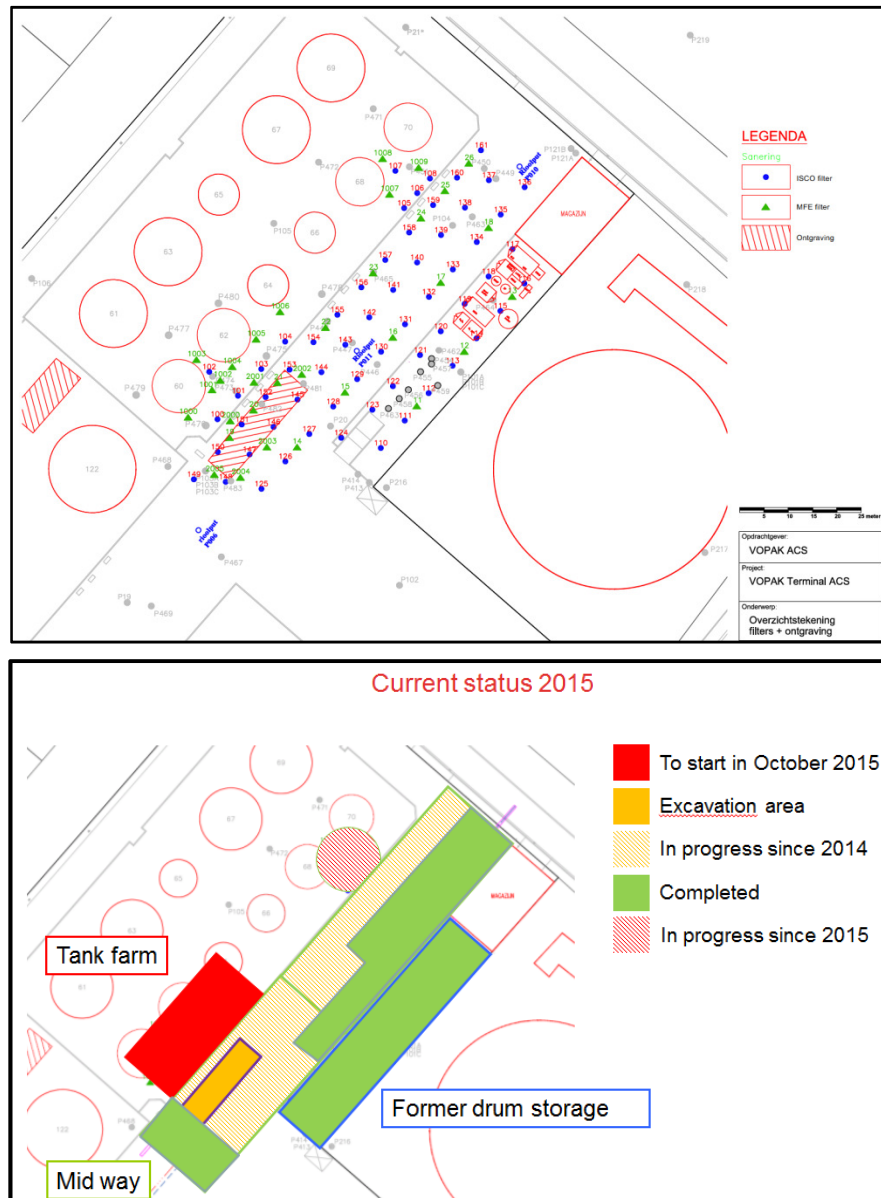
Figure 1. Remediation concept and overview of the remediation progress.

Currently, the remediation targets are reached in the former drum storage and in parts of the midway. The remediation is ongoing in the area in and around the excavation zone (where concentrations have already

drastically reduced), in the area of the midway close to the tank farm and in the small source area in the tank farm.

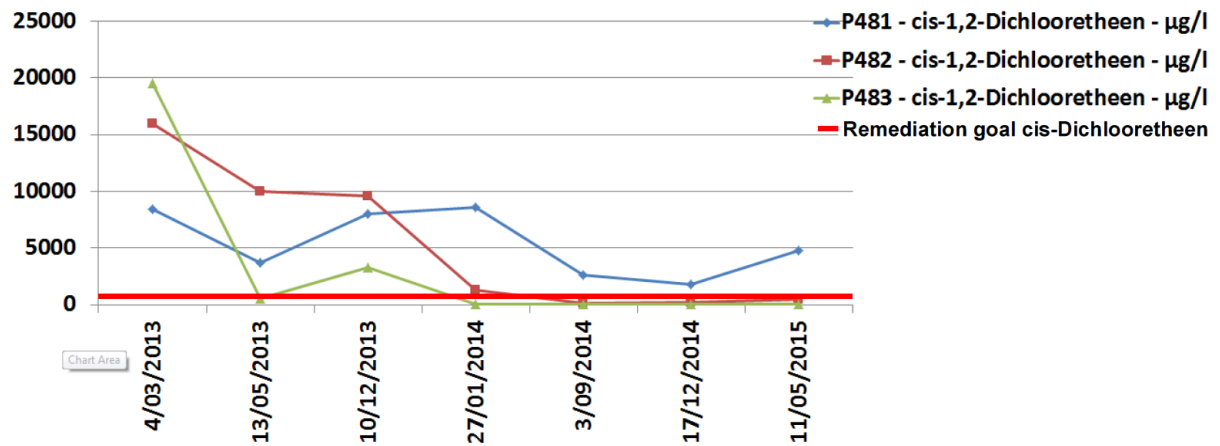
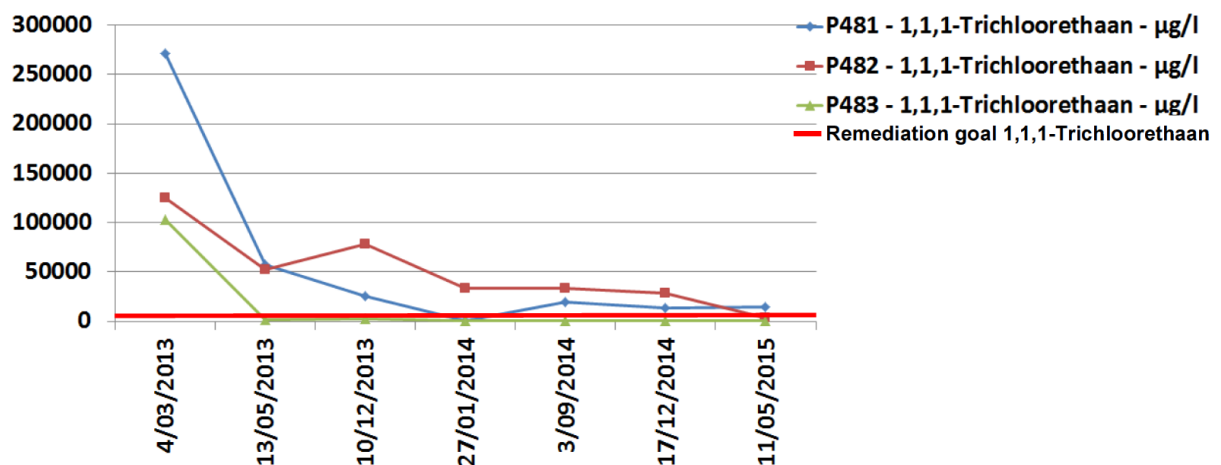
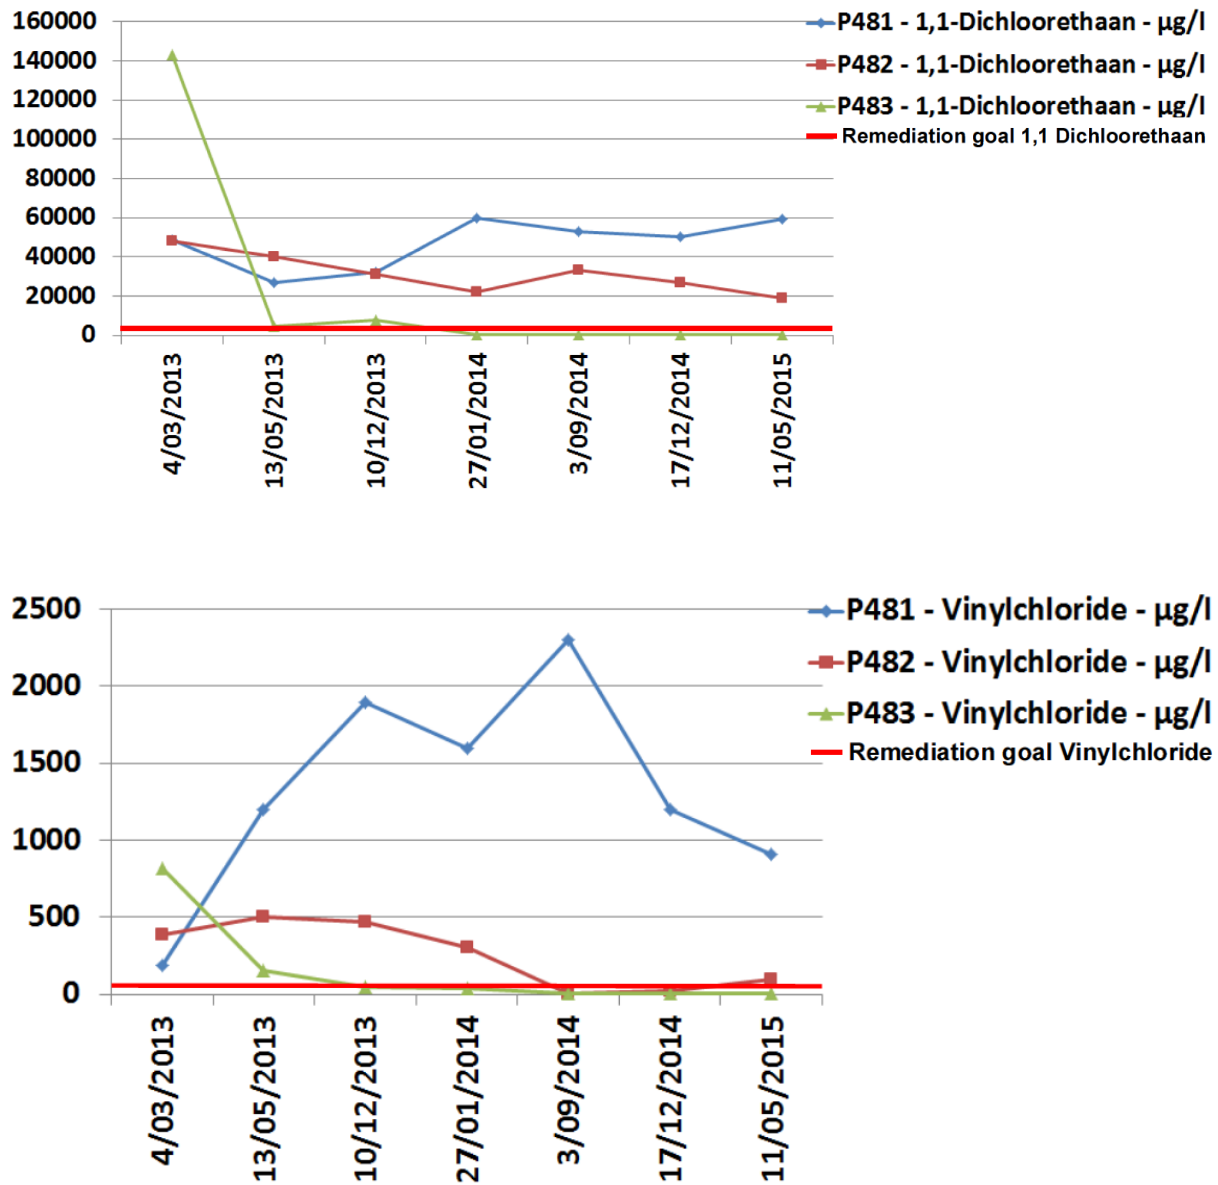
Figure 2. Charts showing the evolution of groundwater concentrations in the monitoring wells during the in situ remediation in the source area around the excavation zone.

Since the start of the remediation beginning 2013, the results can be considered spectacular. An initial strong decrease after the excavation was noticed in the 3 monitoring wells. After a more or less stable period between end 2013 and end 2014 a further decline is obtained for most of the parameters in wells 481 and 482. Only the chloro-ethanes still stay more or less stable. In P482 the remediation targets for all contaminants, except 1,1-DCA and vinylchloride, are reached. The contaminant concentrations in the groundwater around P481 is still high (especially for 1,1-DCA), but has over-all already decreased with about 90% compared to the initial concentrations of beginning 2013. It was expected that the concentrations would stabilize at a certain (high) concentration as long as a high mass is present in the soil (as pure product). At a certain moment, when the mass load and hence the dissolution rate will be reduced enough, the groundwater concentrations will decrease (more strongly).

The third well (P483) shows a spectacular improvement shortly after the excavation. A few months after the ozone injections started the remediation target values were reached. Based on the results of the monitoring events of September and December 2014, the perozone injections around the area of P483 are stopped. The groundwater monitoring of May 2014 confirmed that the concentrations remain stable and that all remediation target values are met, even after Perozone injections were stopped.

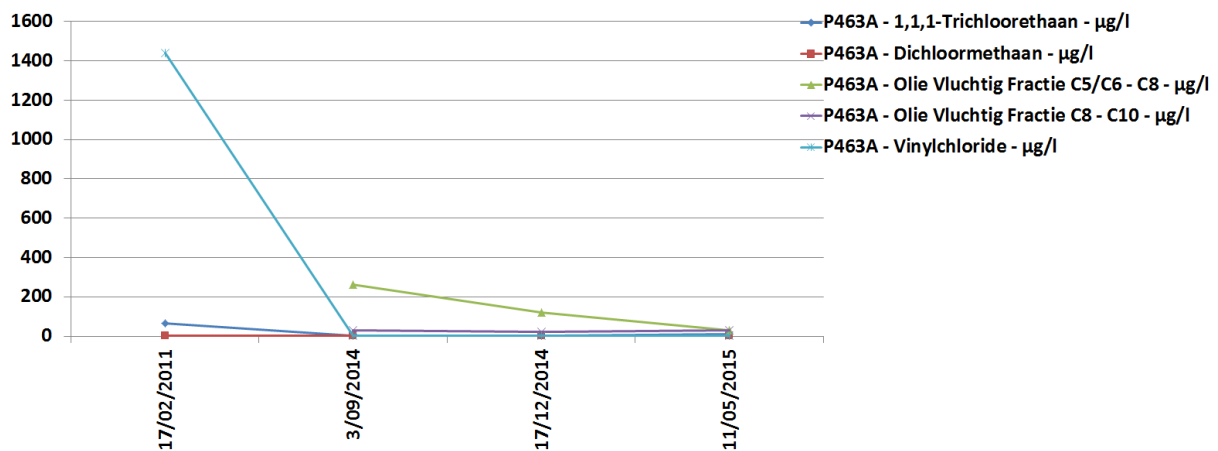
Figure 3. Chart showing the evolution of groundwater concentrations in monitoring well P463A during the in situ remediation (plume area midway).

The remediation target values have been reached in the monitoring wells near the former drum storage area (P446, P449 and P463A). Based on the results of the monitoring events of September and December 2014, the perozone injections in the Midway along the former drum storage are stopped (see Figure 1).

The low groundwater concentrations measured in the monitoring well P463 in May 2015 confirm that the remediation target is reached in the area around this well and no rebound occurs after Perozone injections were stopped.

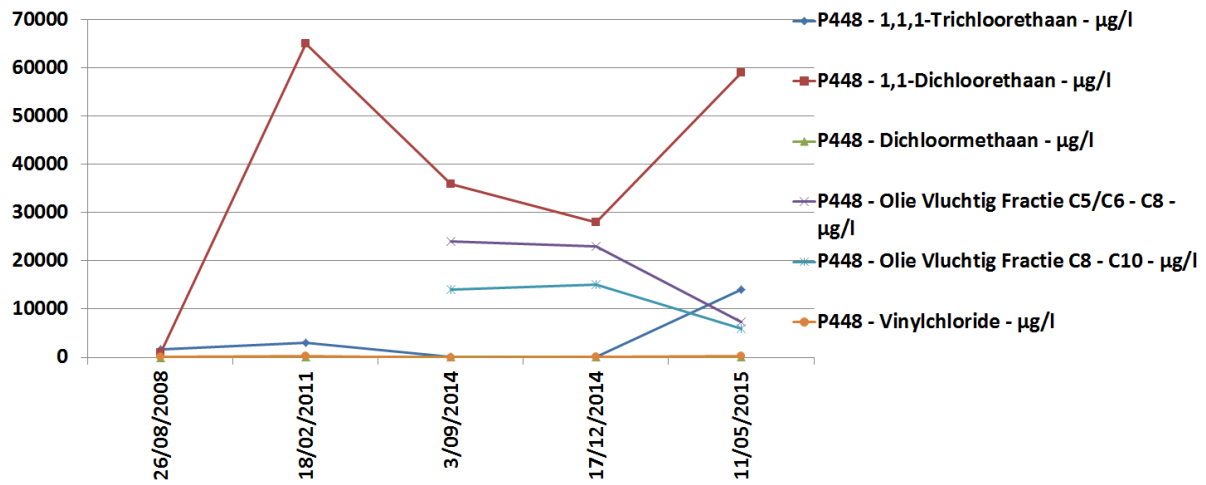
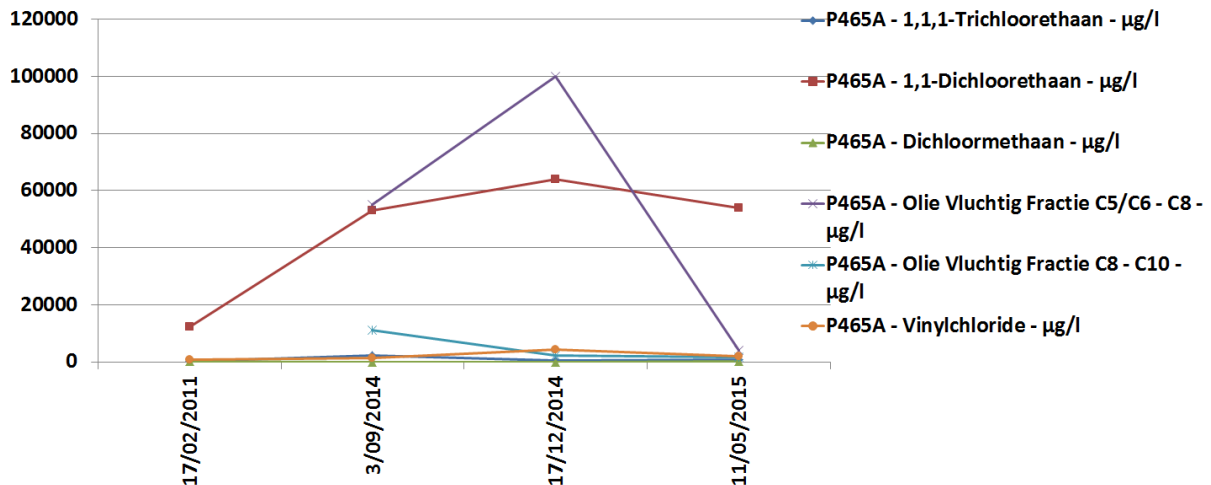
Figure 4. Charts showing the evolution of groundwater concentrations in the monitoring wells during the in situ remediation in the plume area midway.

In the monitoring wells along the tank farm (P447, P448, P450 and P465) the remediation target values are reached for almost all contaminants except for volatile TPH in most wells and chloro-ethanes in P448 and P465. In P448 1,1-dichloroethane and 1,1,1-trichloroethane have increased (unexpectedly). This needs to be checked in the next monitoring event. P450 has not been sampled in 2015 because the remediation targets were reached in September 2014.

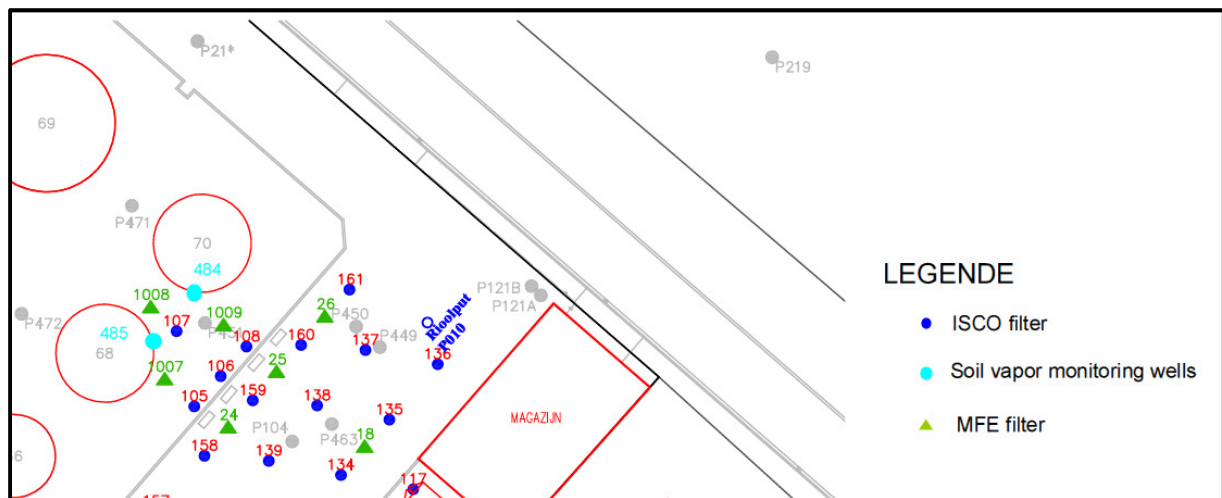
Figure 5. Indication of the positions of the soil vapor monitoring wells in the tank farm.

End 2014 phase 3, the remediation by ISCO of the small source area in the tank farm, has been prepared. One of the main risks in the tank farm is the corrosion of the tank floor due to ozone emissions. The tank farm itself is liquid tight but the storage tanks are built on a foundation of stabilized sand and hence the tank floors may come in contact with ozone.

Two soil vapor monitoring wells have been installed in the tank farm. The 2 wells are installed just next to the two storage tanks that are situated in the injection influence radius. Possible ozone emissions should be captured by the vertical soil vapor extraction wells/MFE-filters (1007-1009) situated around the injections wells (see figure). The efficacy of this system will be monitored by the two soil vapor monitoring wells. If ozone concentrations or increased oxygen concentrations are detected in the vapor monitoring wells, the injections will be stopped immediately and additional actions have to be implemented to prevent contact of ozone with the tank floors.

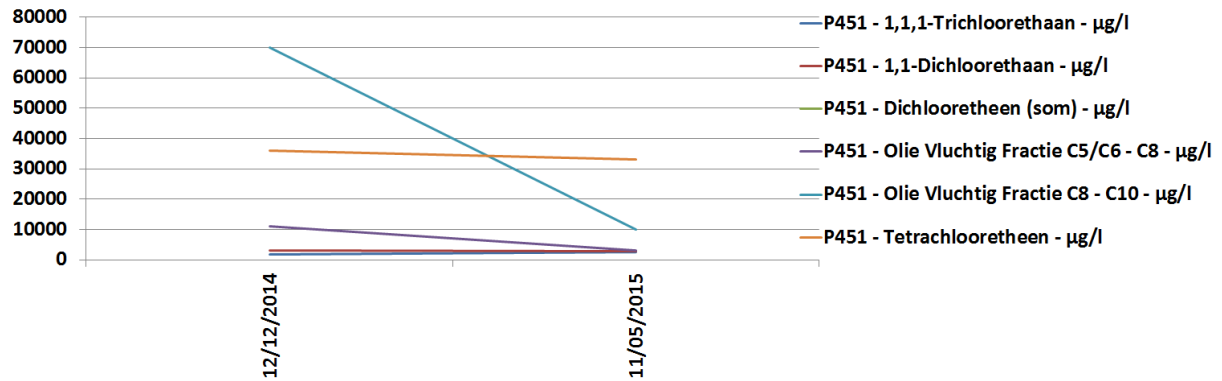
Figure 6. Charts showing the evolution of groundwater concentrations in the monitoring wells during the in situ remediation in the small source area in the tank farm.

After only 2 months of injections in the small source area of the tank farm (P451) the concentration of volatile total petroleum hydrocarbons has decreased remarkably. The chloroethanes and chloroethenes remain more or less stable.
