LIFE+ project Vopak ExperO3

Newsletter nr. 6 – May 2017

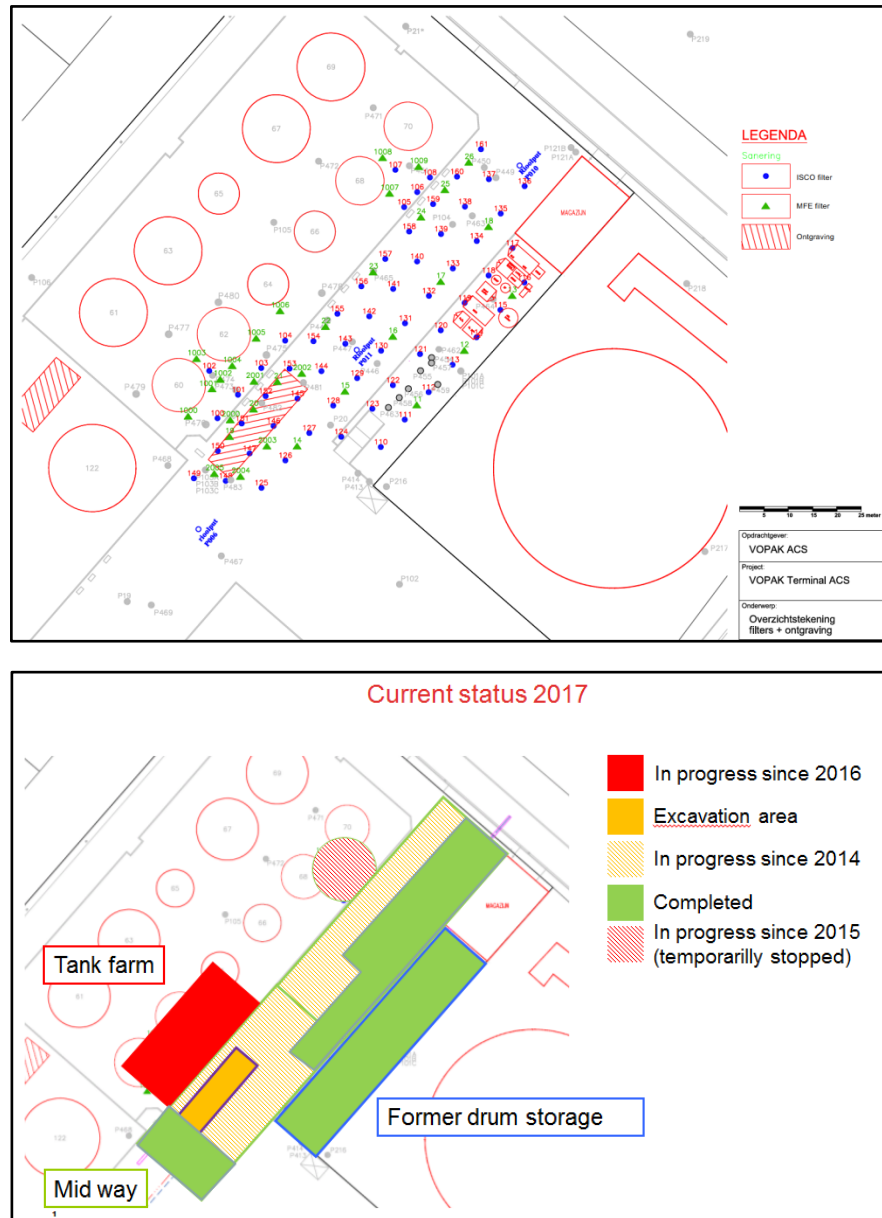
Figure 1. Remediation concept and overview of the remediation progress.

Currently, the remediation targets are reached in the former drum storage and in parts of the midway. The remediation is ongoing in the area in and around the excavation zone (where concentrations were already drastically reduced but are increasing again), in the area of the midway close to the tank farm and in the small source area and big source area in the tank farm.

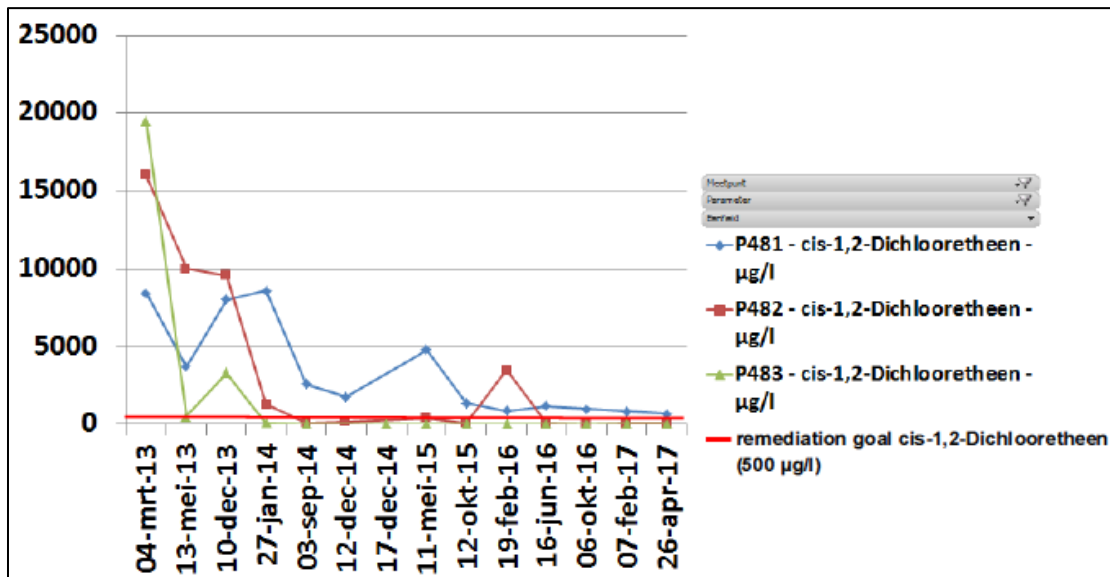
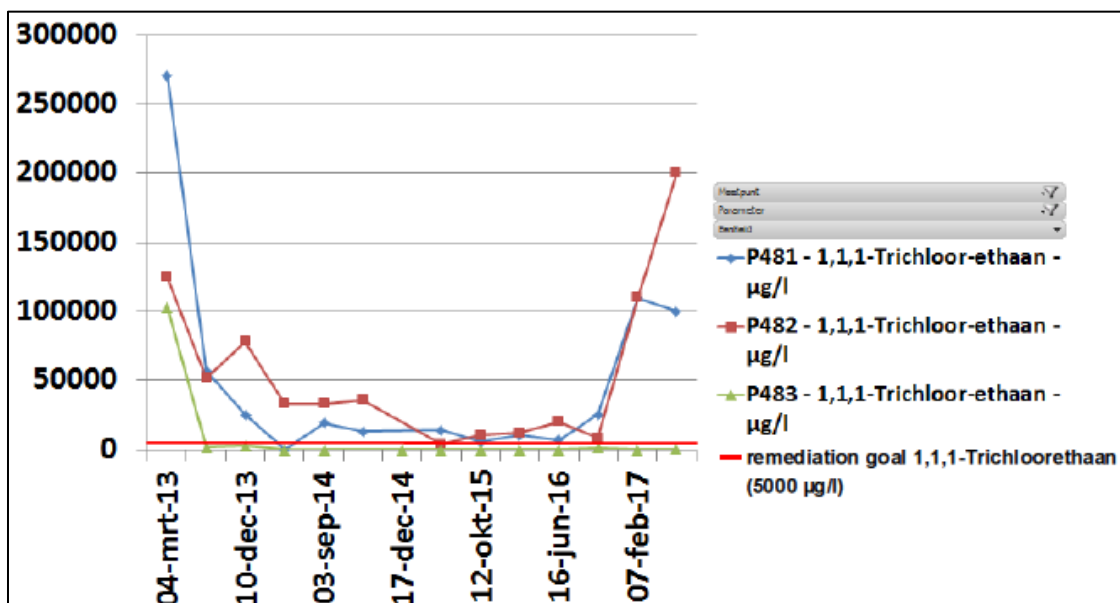
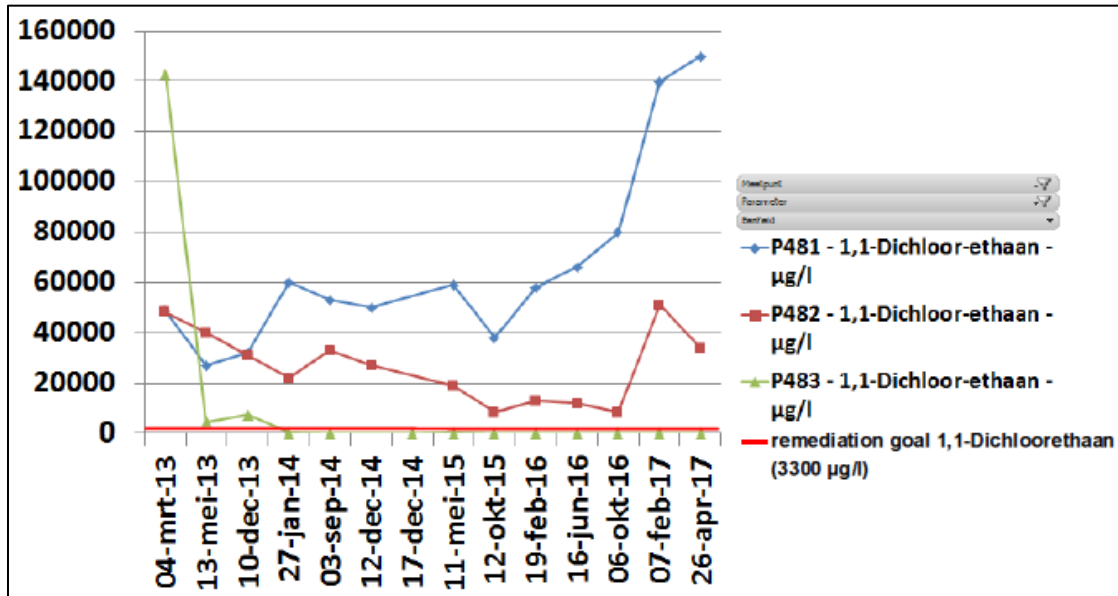
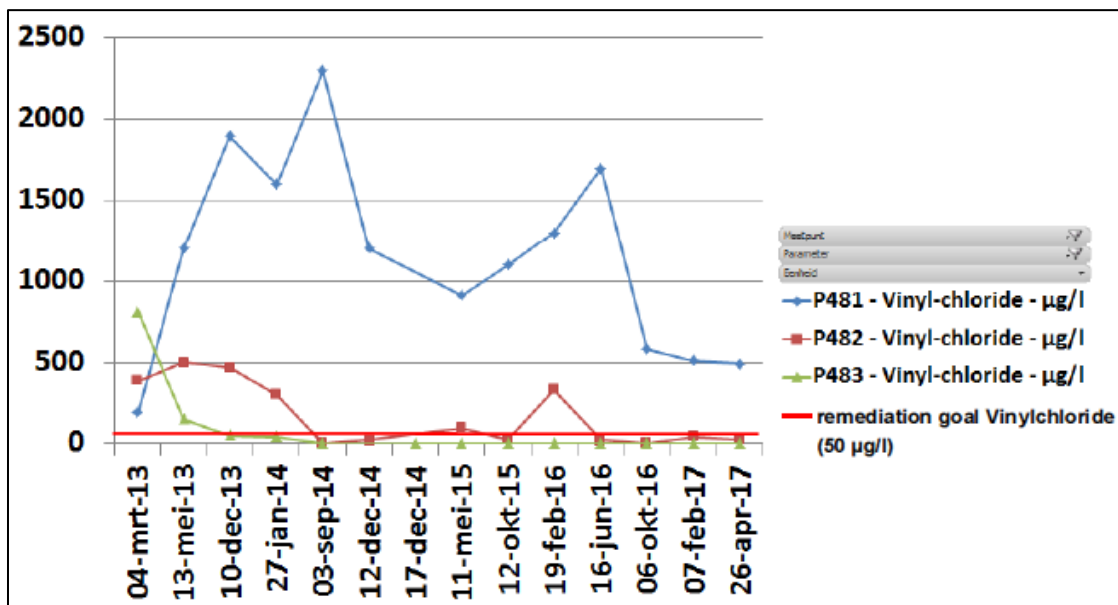
Figure 2. Charts showing the evolution of groundwater concentrations in the monitoring wells during the in situ remediation in the source area around the excavation zone.

Since the start of the remediation beginning 2013, the results can be considered spectacular. An initial strong decrease after the excavation was noticed in the 3 monitoring wells. After a more or less stable period between end 2013 and end 2014 a further decline is obtained for most of the parameters in wells 481 and 482. Only the chloro-ethanes still stay more or less stable. In P482 the remediation targets for all contaminants, except 1,1-DCA and 1,1,1-TCA, were reached. The contaminant concentrations in the groundwater around P481 were still high for 1,1-DCA and VC. The remediation goals for 1,2-DCE and 1,1,1-TCA were nearly reached. Generally the contamination in P481 was decreased with about 90% compared to the initial concentrations of beginning 2013. It was expected that the concentrations would stabilize at a certain (high) concentration as long as a high mass is present in the soil (as pure product). At a certain moment, when the mass load and hence the dissolution rate will be reduced enough, the groundwater concentrations will decrease (more strongly).

Results of the last campaigns show an increase of the contamination concentration in the groundwater of well P481 and P482 mainly of chloro-ethanes. This indicates that there are still source areas with high concentrations in the soil or even pure product. The reason why this product is released since February 2017 needs to be further investigated. On going civil works in the surroundings could have influenced the remediation area with these results.

The third well (P483) shows a spectacular improvement shortly after the excavation. A few months after the ozone injections started the remediation target values were reached. Based on the results of the monitoring events of September and December 2014, the perozone injections around the area of P483 are stopped. The groundwater monitoring of June 2016 confirmed that the concentrations remain stable and that all remediation target values are met, even after Perozone injections were stopped.

The injections in the excavation zone around P481 and 482, in the Midway along the tank farm and in the big source area in the tank farm will be continued. Further investigation of the cause of the increasing concentrations around P481 en P482 is needed. As soon as capacity becomes available the injections in the small source area need to be restarted. The duration of the injections in the high mass zones will be longer than initially estimated due to the H&S limits of the vapour emissions. However, both further optimization of the injection regime should be considered depending upon the results in the near future without causing emissions in order to accelerate the remediation.

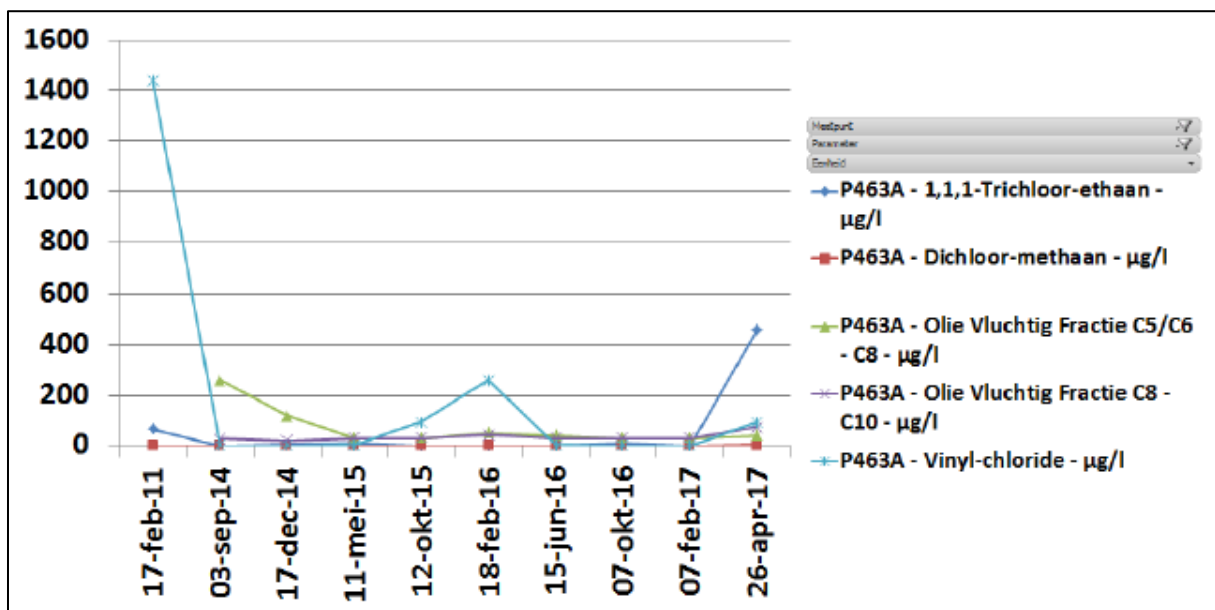
Figure 3. Chart showing the evolution of groundwater concentrations in monitoring well P463A during the in situ remediation (plume area midway).

The low groundwater concentrations measured in the monitoring well P463 in april 2017 confirm that the remediation target, except for vinyl chloride, is reached in the area around this well and no relevant rebound occurs after Perozone injections were stopped.

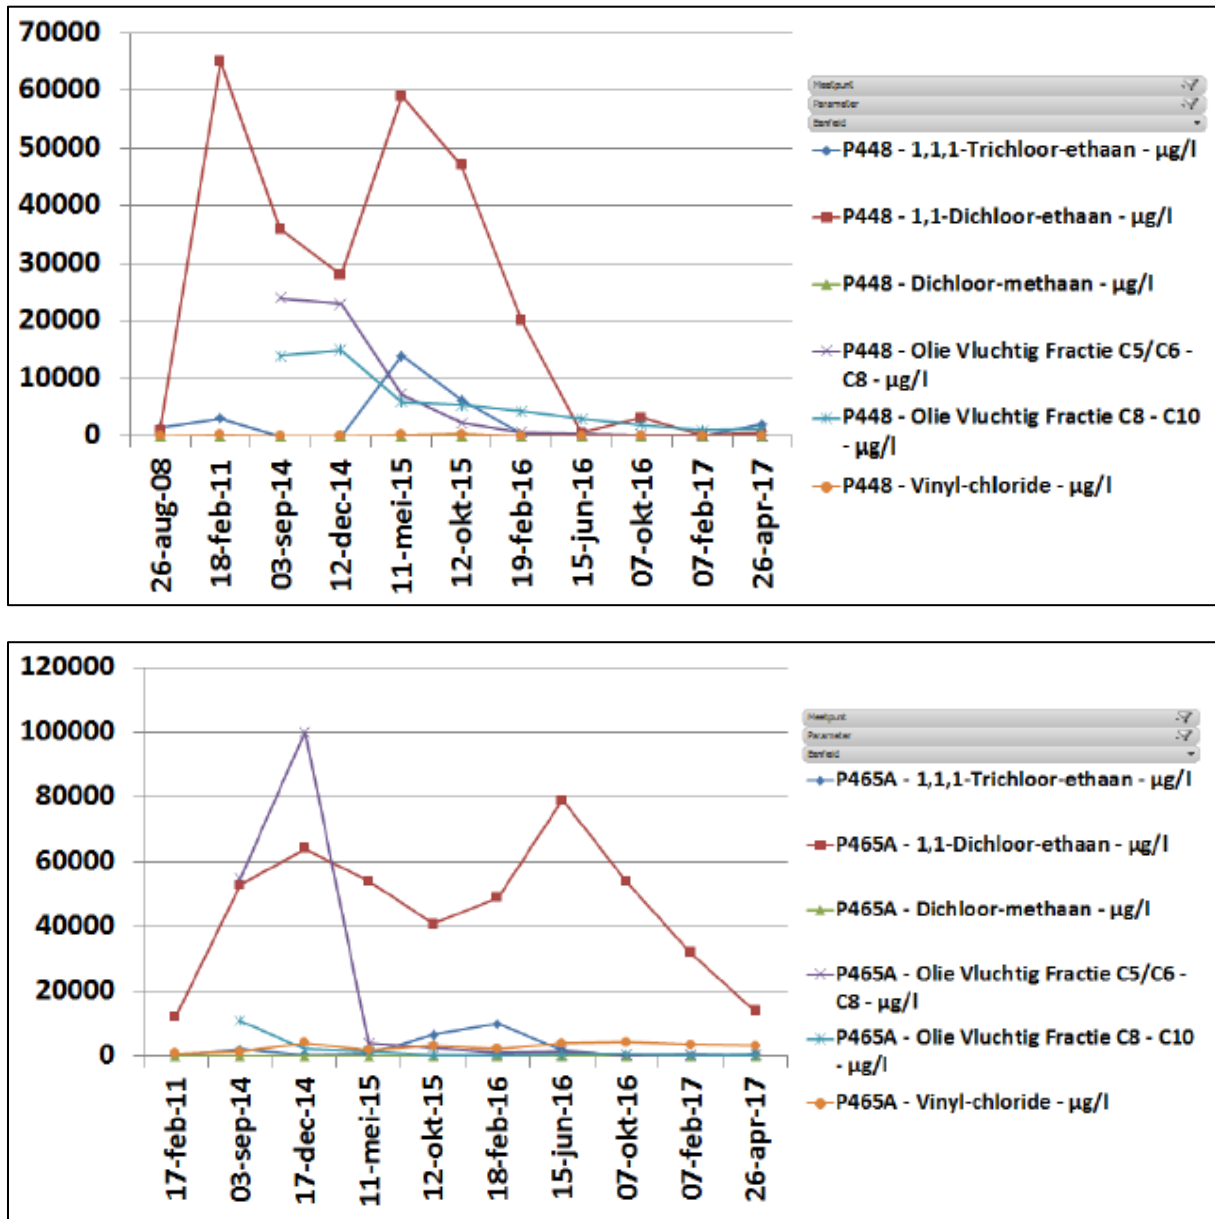
Figure 4. Charts showing the evolution of groundwater concentrations in the monitoring wells during the in situ remediation in the plume area midway.

In the monitoring wells in the midway along the tank farm (P447, P448, P450 and P465) the remediation target values were reached for almost all contaminants except for 1,1-dichloroethane, cis-dichloroethene and vinylchloride in P465. After fluctuating concentrations, 1,1 dichloro-ethane in P448, met in June 2016 the remediation goal for the first time. In P465A 1,1-dichloroethane continues decreasing. Further evolution needs to be checked in the next monitoring events but the results stay very encouraging.

P450 has not been sampled in 2017 because the remediation targets were reached in September 2014.

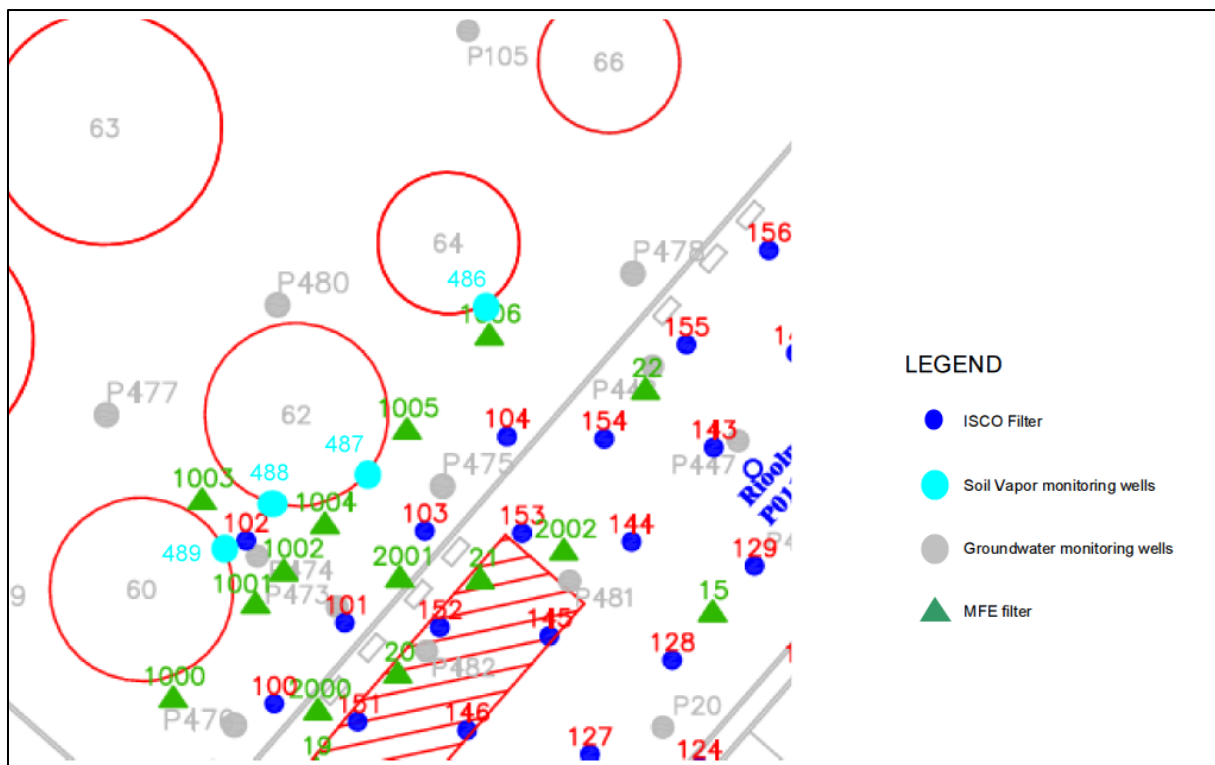
Figure 7. Indication of the positions of the soil vapor monitoring wells in the tank farm.

Four soil vapor monitoring wells have been installed in the tank farm. The 4 wells are installed just next to the 4 storage tanks (60, 62 and 64) that are situated in the injection influence radius. Possible ozone emissions should be captured by the vertical soil vapor extraction wells/MFE-filters (1000-1006) situated around the injections wells (see figure). The efficacy of this system will be monitored by the four soil vapor monitoring wells (486, 487, 488, 489). If ozone concentrations or increased oxygen concentrations are detected in the vapor monitoring wells, the injections will be stopped immediately and additional actions have to be implemented to prevent contact of ozone with the tank floors.

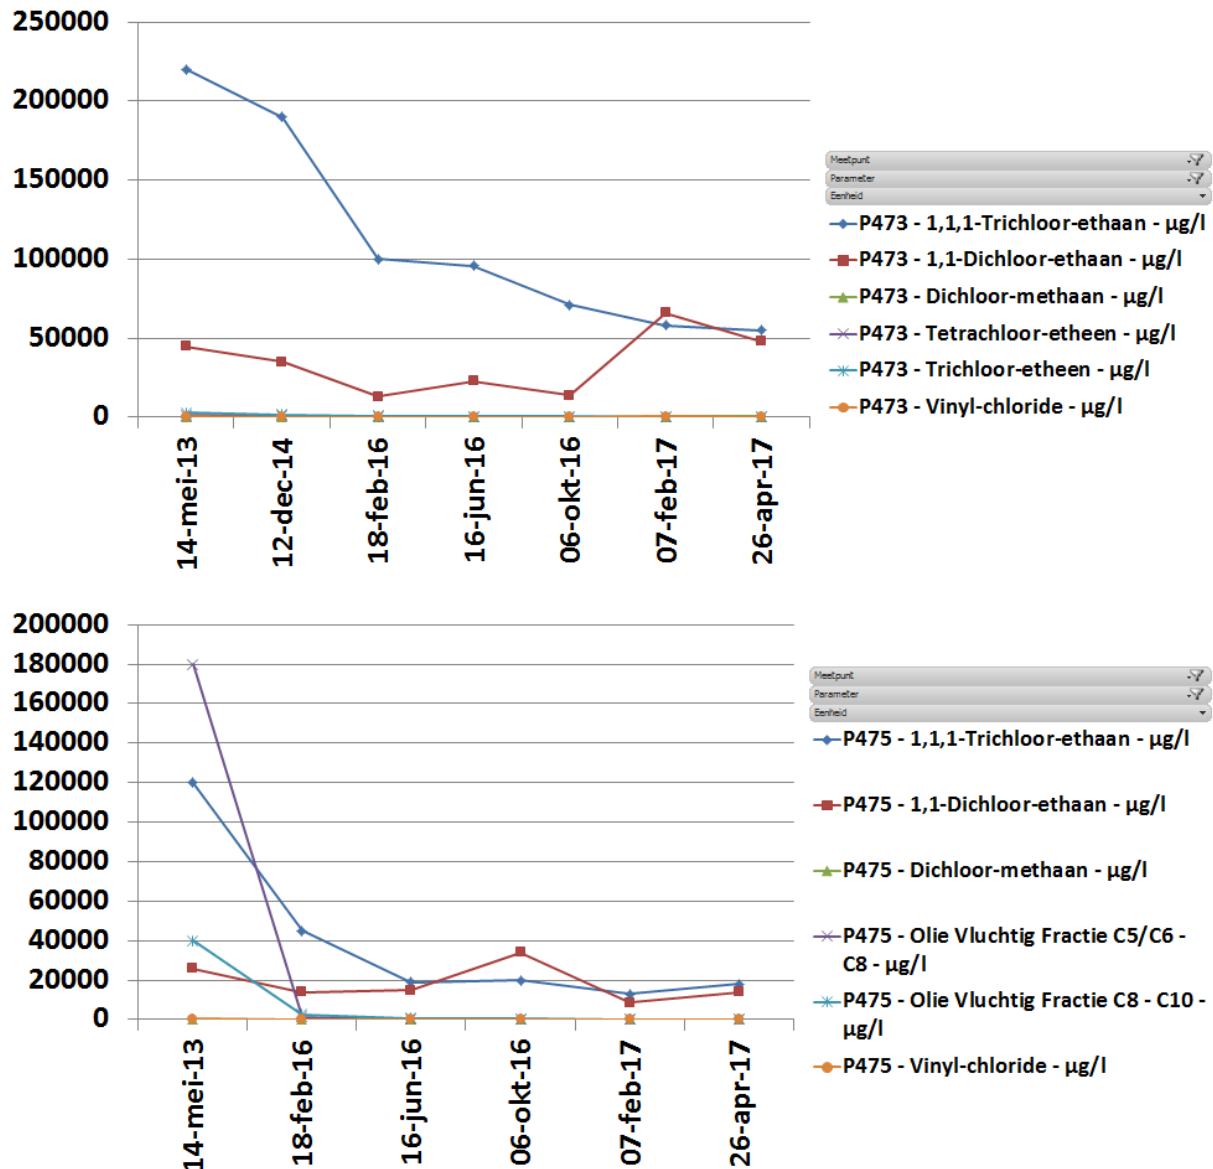
Figure 8. Charts showing the evolution of groundwater concentrations in the monitoring wells during the in situ remediation in the big source area in the tank farm.

Exceedance of remediation goals are only observed in wells P473 and P475. After one month of injections in the big source area of the tank farm the concentration of volatile total petroleum hydrocarbons and also the chloro-ethanes has decreased remarkably in these wells. After more then a year these concentrations remained more or less stable above the remediation goals.
